Date of Report: November 12, 2020

Bobcat Fire 2020

*Big Santa Anita Canyon*

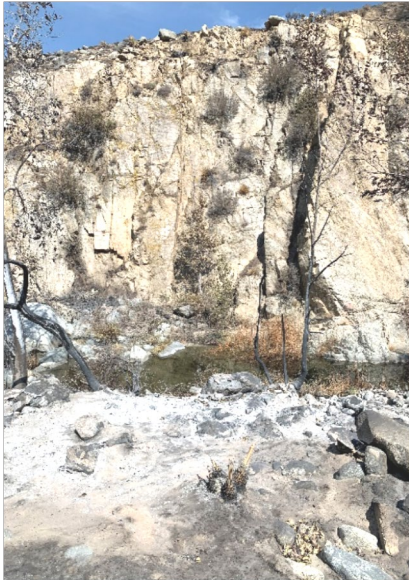
Weed detection surveys to determine whether ground disturbing activities related to the Bobcat Fire have resulted in the expansion of noxious weeds is requested for the first year. EDRR funding is requested for areas throughout high, moderate, and low burn severities as low soil burn severity does not always correlate to significant amounts of remaining vegetation. For example, on the northern portion of the fire a significant amount of low burn severity is recorded. The vegetation in this area is characterized as desert transition, dominated by bunch grasses, cacti, and some desert shrubs. The fire burned off the majority of this vegetation, even in areas characterized as low burn severity, leaving this area extremely vulnerable to invasion by weeds, which is well known to be even more catastrophic in desert environments (see picture below).

Surveying will include walking the priority areas, documenting and hand pulling/herbicide new weed occurrences at the time of inspection. Herbicide will be used in compliance with the Forest Wide NEPA project. New weed occurrences will be pulled to root depth, placed in sealed plastic bags, and properly disposed or sprayed with the appropriate and approved herbicide.
